1967 Thru 1986  
***APACHE***  
Lift Systems  
Parts and Service Manual

## Section 1. 1971 thru 1987 Lift System

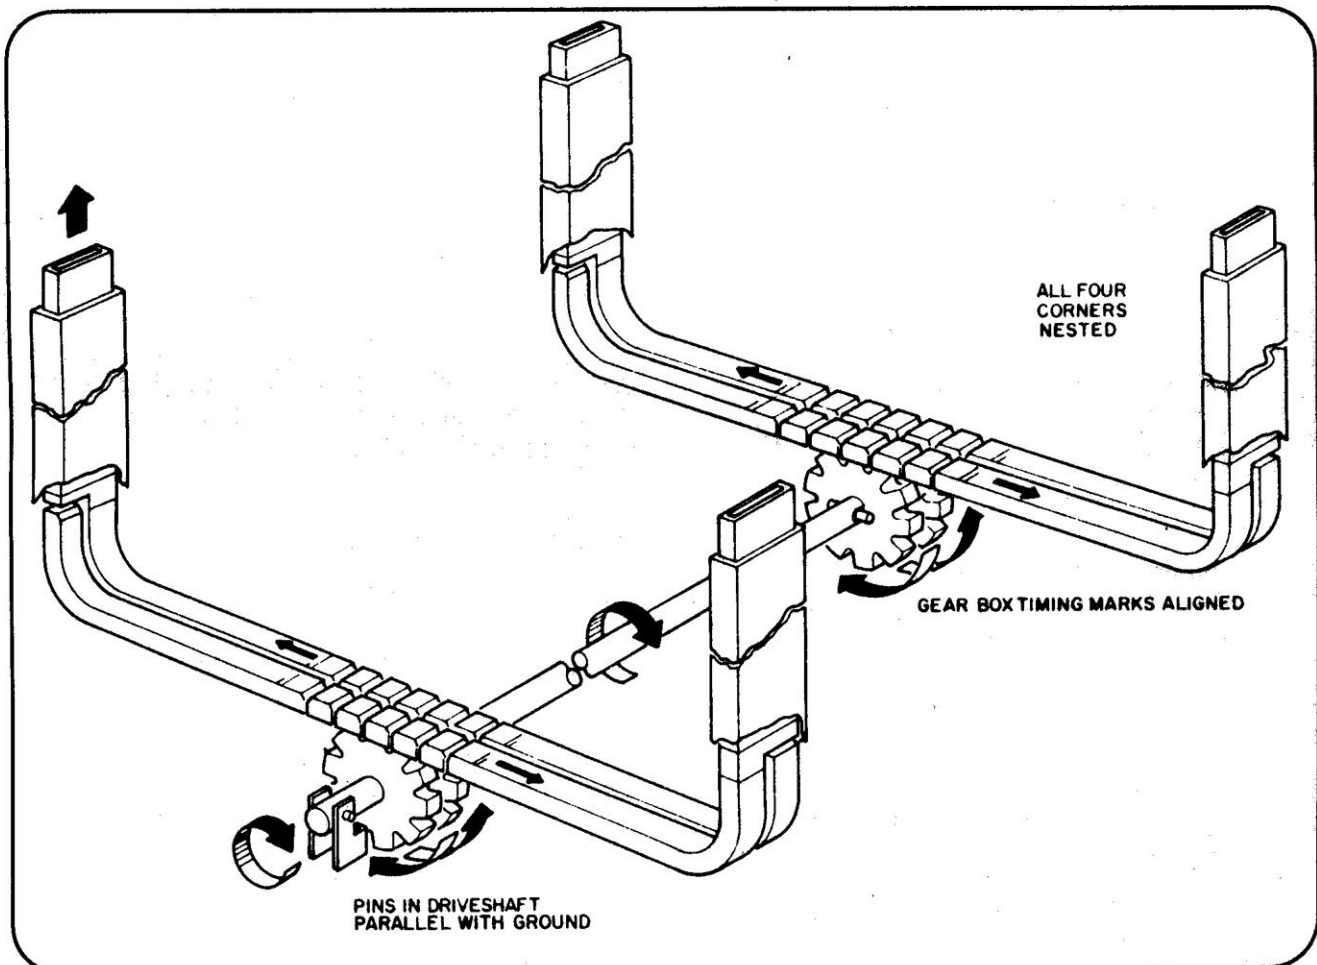
Figure 1. Lift System Operation

The entire lift system and its movement during raising, are shown in Figure 1.

The rear gear box receives the torque of the crank and transfers Each gear box, consisting of two sprockets, drive gear and shaft, actuate the lifting chains. it to the front gear bow through the connecting tube. Each gear box, consisting of two sprockets, drive gear and shaft, actuate the lifting chains. When raising, the gear box is pushing the chains up. Therefore little if any force is applied to the cable connecting the chain links. In turn, the chain pushes up the inner telescope extrusion to which it is attached. The middle telescope extrusion is free floating first

raising by friction and later by the engagement of the stops.

a. GENERAL. The lift system shown in figure 1 is a closed system in time. Essentially it is in time since all corners are down together. This closed position is the reference point to which we can return to resolve timing problems.

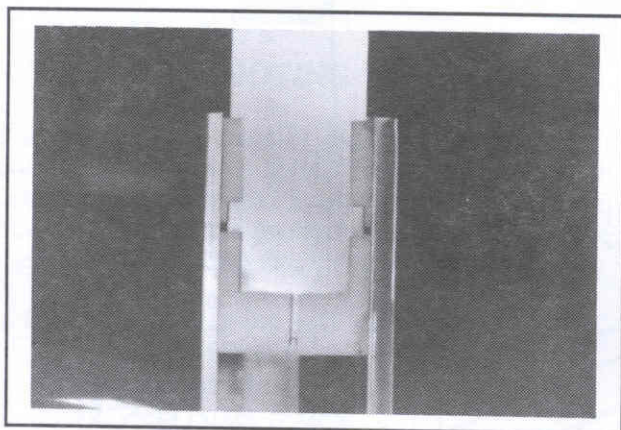
Figure 3. Outer and Middle Stops

1.CHECK. Raise road cover half way and slide middle telescope extrusion up and down. The extrusion should slide up and down without excessive force. Perform this on all four corners. Any difficulty in sliding indicates binding stops.

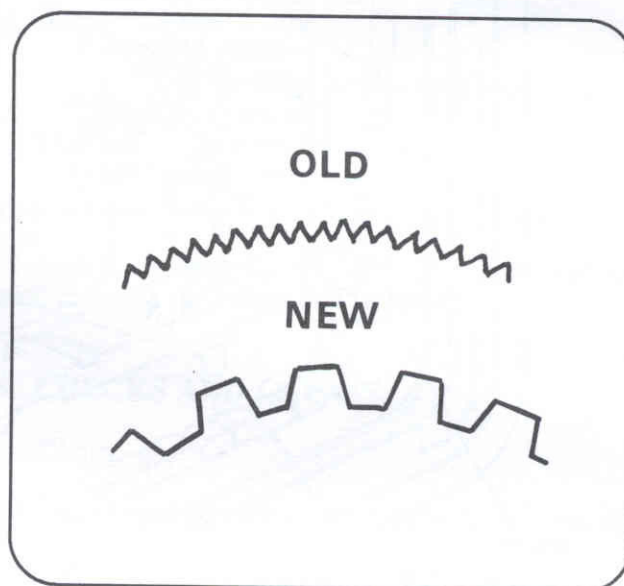
Figure 4. Old and New Style Gears

1. CHECK. With the road cover closed, drop the gear box (para.6a). Inspect the drive gear, pin or dog eared plate, and sprockets for cracks or damaged teeth. Disassemble the gear box (para.6b) to examine the fine teeth between sprockets and drive gear. The size of these smaller teeth was changed in 1977. This of course, changed the cranking ratio and prohibits mixing old and new style gear boxes. Although the plastic gears are no longer available, an aluminum gear kit is. The kit has the larger tooth design so if you have old style boxes you will have to rebuild both ends.

Essentially, the same gear box was used on Apaches from 1971 on. The important difference is that in 1977 the gear ratio between the drive gear and sprockets was changed. This change is commonly referred to as old style (71-76 with fine teeth) and new style (1977 and on with coarser teeth). This kit directly replaces the new style. On old style, both gear boxes must be rebuilt to keep the gear ratio the same.

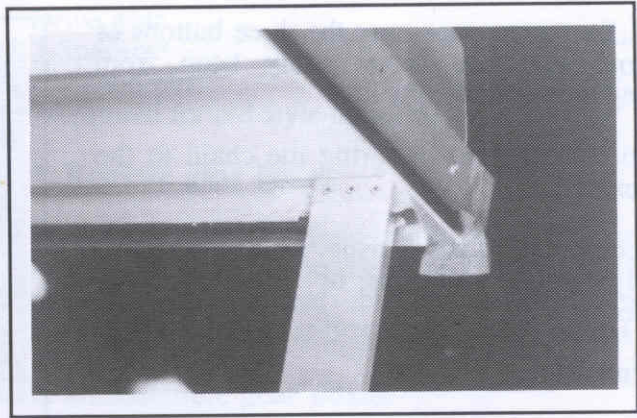
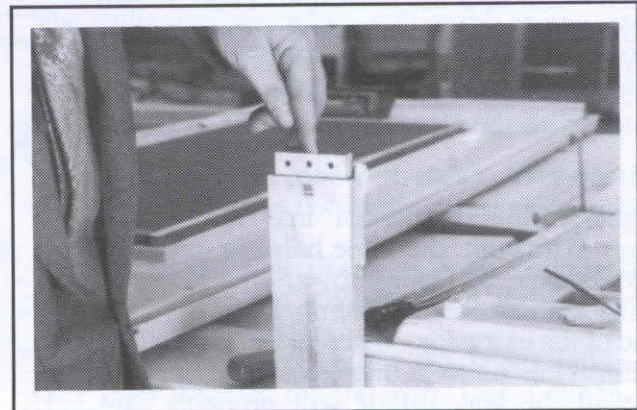
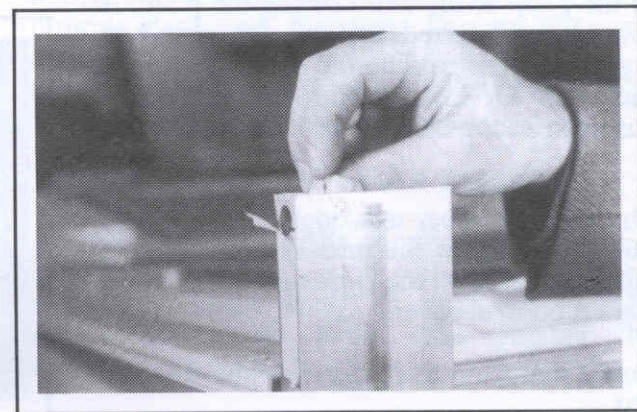
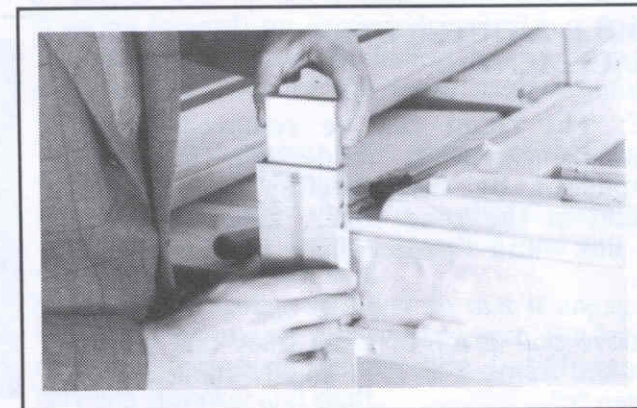
*Figure 5 Chain Removal*

1. Raise road cover and secure sidewall in place.
2. Drill out the three rivets holding the telescope extrusion to the road cover (fig.5). Attach a wire to one of the holes with about 6" of free wire sticking up.
3. Drop gear box (para.5A). Try not to disturb gear box timing so that it'll be easier to reinstall.
4. Push the inner extrusion down into the middle extrusion until it is below the stops (fig.5). Remove the stops (fig.5). Grab the wire and pull the inner extrusion back up and along with it the chain. Continue pulling the chain until it is completely out.

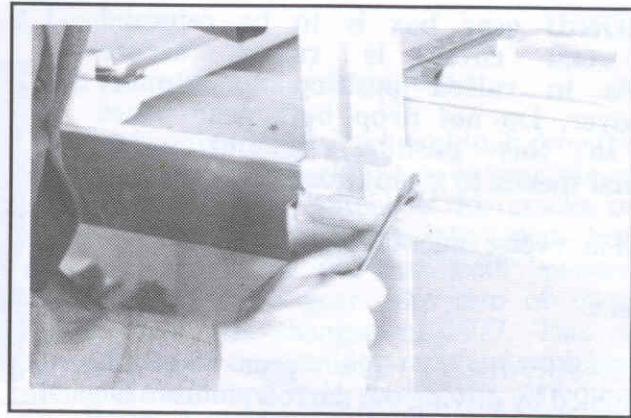
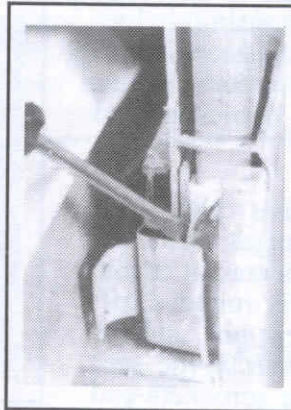
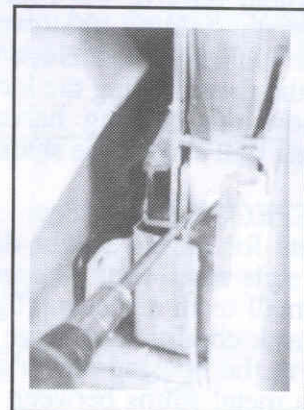
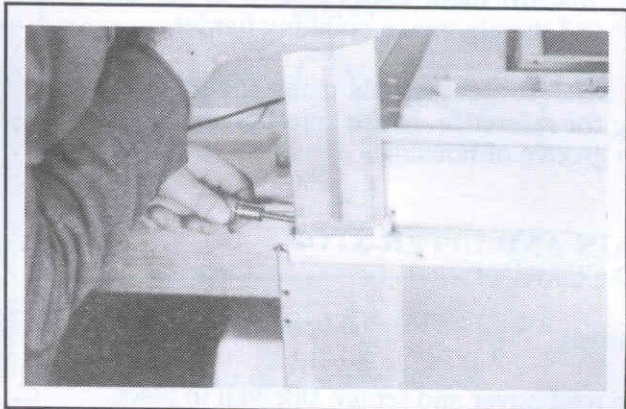
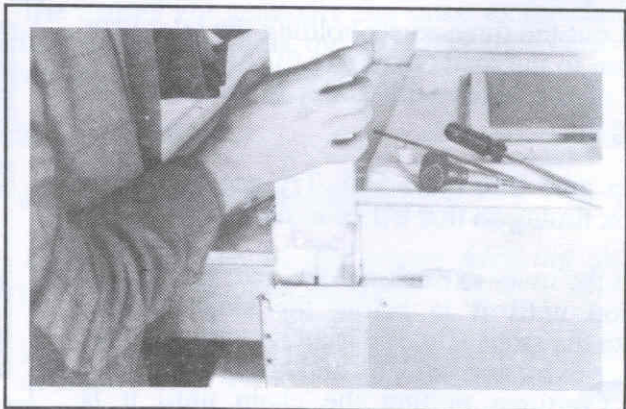
*Figure 6. Stop Removal*

c. Using a screwdriver, pry open the chain track extrusion as shown in fig. 6.

d. Using a pointed tool, pry up on upper stop as shown in fig. 6 and remove. Grasp post, pull forward and pry up on the opposite stop, again fig. 6.

e. Middle telescope extrusion can now be pulled up to expose the lower stops as shown in fig.6.

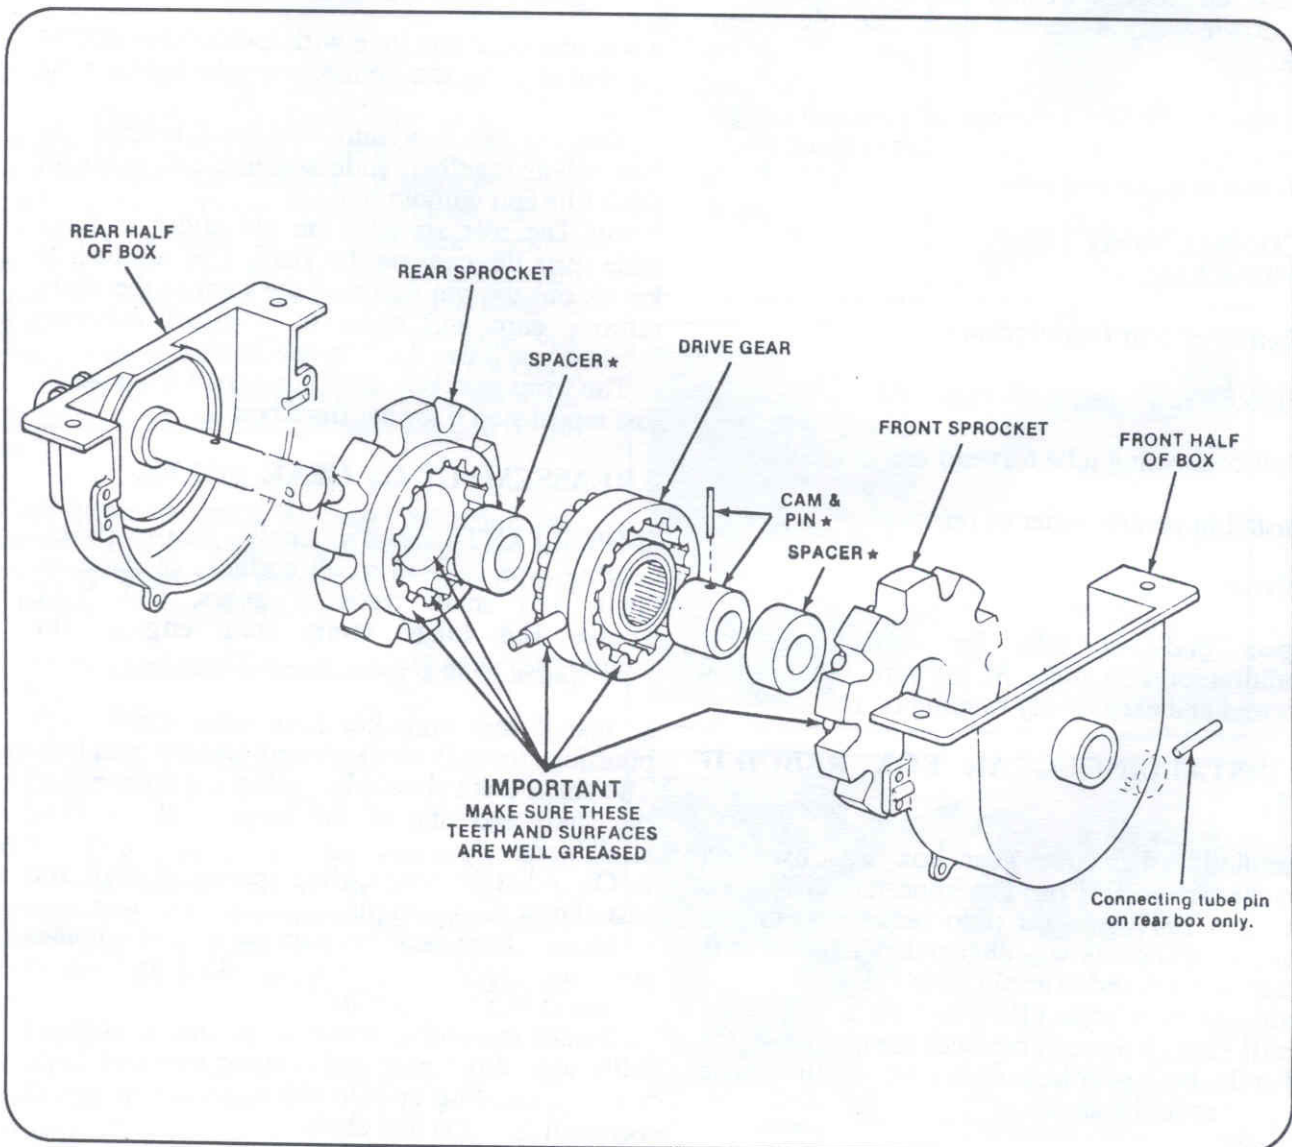
Figure 7. Gear Box Assembly (1971-1987)

a. Install rear sprocket (one with small teeth pointing inward) on shaft and against box half. The small teeth should be facing the open end of the shaft and one of the large teeth pointing straight up.

b. On old style boxes, slide spacer on shaft and install new cam with pin.

c. Install drive gear on cam so that it engages with the sprocket already installed and pin is seated in recess of box half.

d. Install remaining sprocket so that it engages fully with drive gear and making sure one large tooth is pointing up. On old style, install spacer between sprocket and shaft.

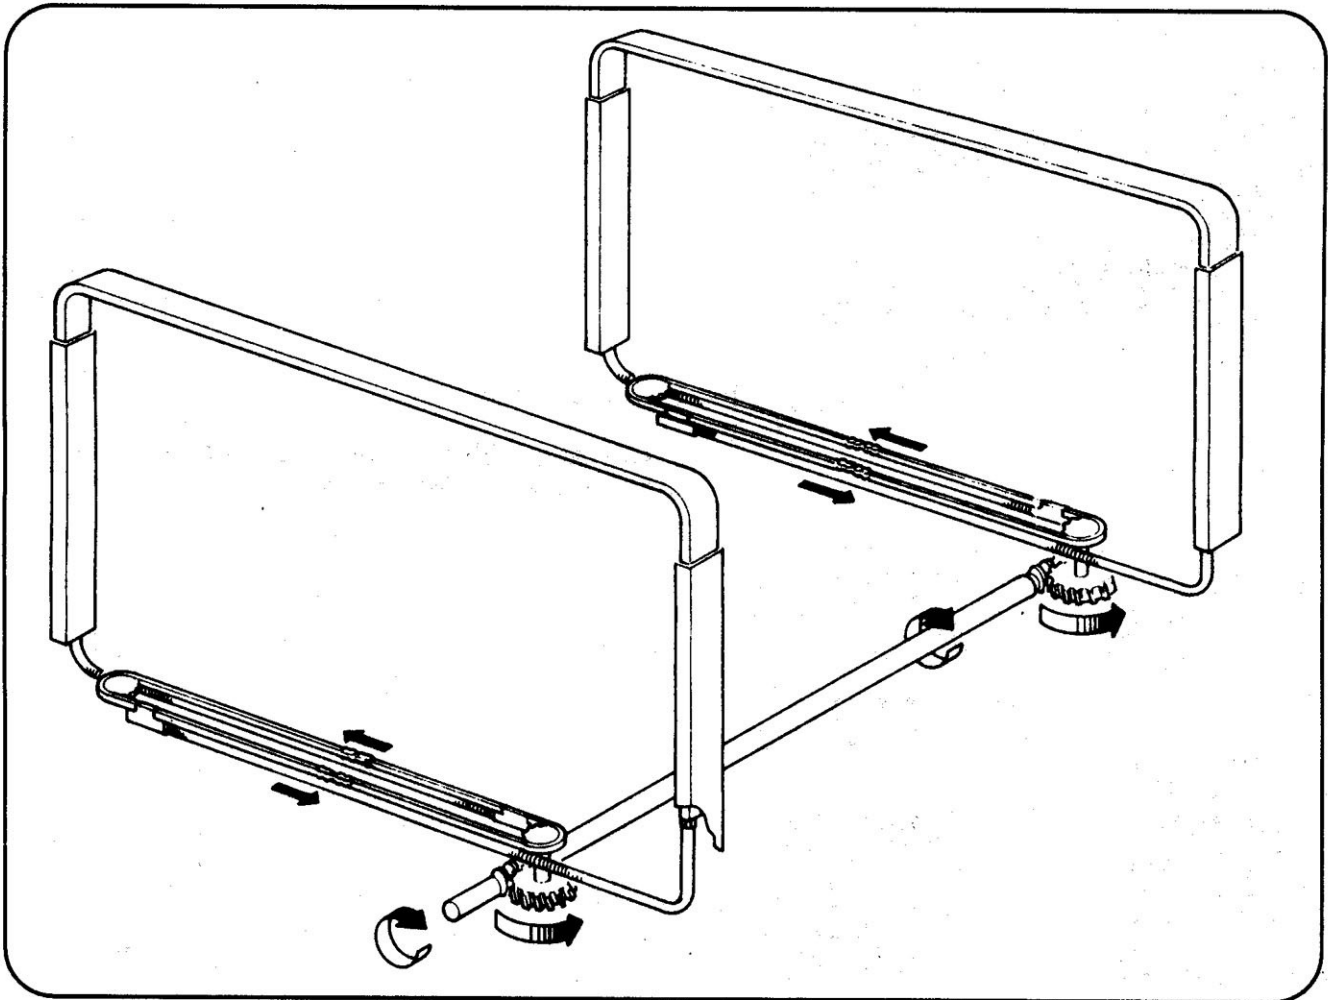
Figure 8. Lift System Operation - 1970

The overall lift system and its operation in raising is shown in figure 8.

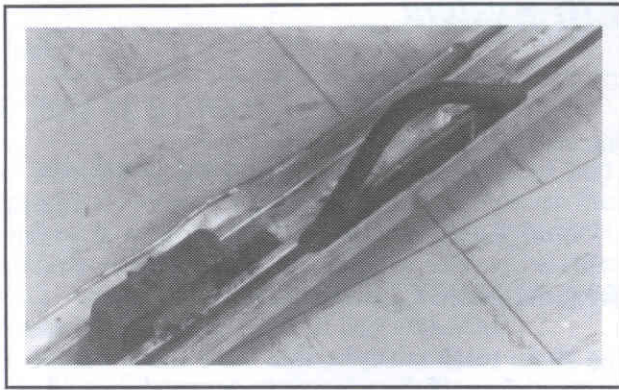
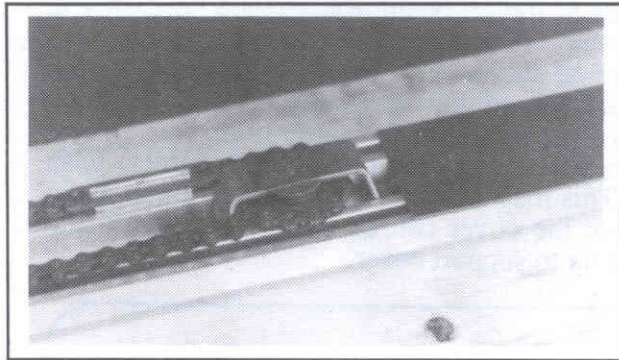
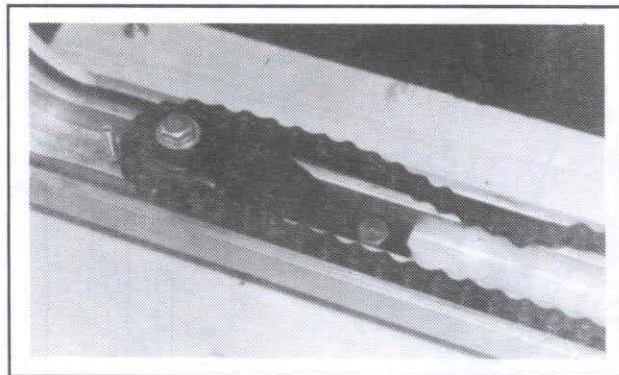
*Figure 9. Kinked, Jammed, and Loose Chains.*

- a. Road cover is jammed in up position or won't raise.
  - 1. Push spring kinked or jammed.
  - 2. Chain jammed at sprockets.
- b. Front end will not raise.
  - 1. Loose or broken chain.
  - 2. Drive pin at connecting tube broken.

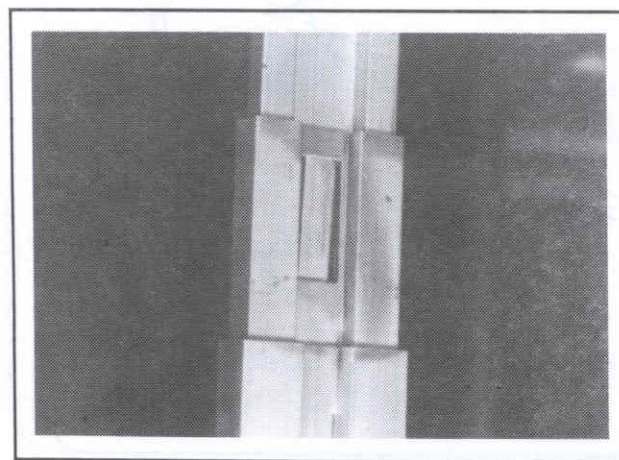
*Figure 10. Stop Tangs*

b. Depress the tang which holds the middle lift post in place. Push down on the middle extrusion (figure 10). This will expose the cable so that the cable can be removed.

g. Raise the middle post extrusion so that the tang is engaged (figure 10).

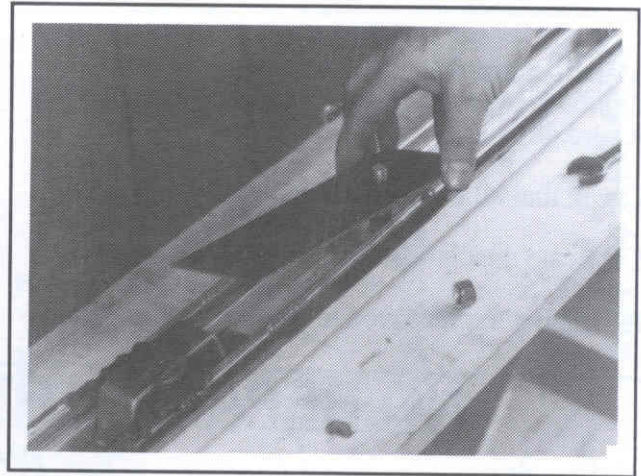
*Figure 11. Removing Push Spring*

e. Disconnect the chain from the follower of the damaged cable. Then, remove the cable-spring and follower through the elongated slot in the chain track extrusion (figure 11).

h. Place a 2-3/4" x 8" 11 gauge steel plate (figure 11) part no. 1900694 over slot in chain track, if one wasn't there originally. This plate keeps the spring from jamming or kinking at the slot. If the plate was not installed, check other end and install plate if missing.

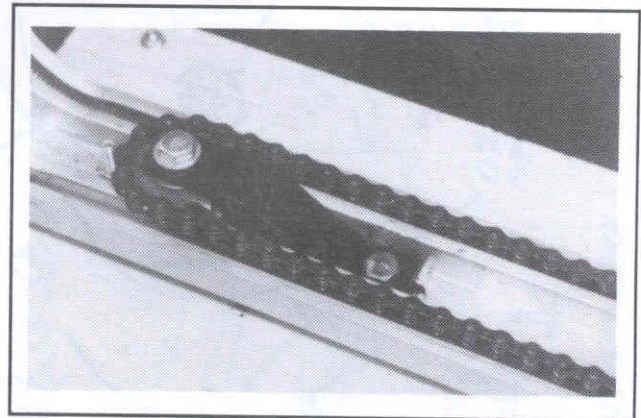
*Figure 12. Chain Adjustment*

5. Chain Adjustment (figure 12).

The chain must be tight for proper operation. Adjusting the tightness is simply accomplished by loosening the idler sprocket bolt and moving as required for tightness.

i. Check and make certain that the idler sprocket is adjusted so that the chain is tight (see para.5B.5). Tighten idler sprocket bolts (figure 12).

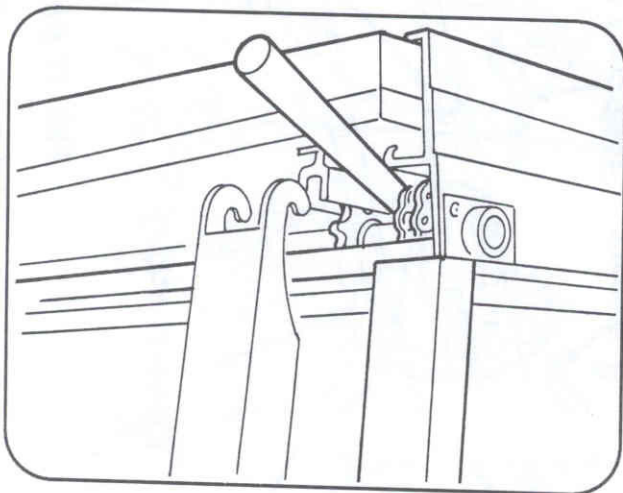
Figure 15. Retiming Beds.

Insert pry bar between the sprocket shaft and the bed. Using the pry bar, lift the bed up jumping it over the sprocket to the next link in chain. Jump links in this fashion until the bed is back in time. If the bed keeps jumping out of time an adjustment in the corner shaft plates is necessary Figure 15. See para.2 on Chain drive Slippage and Beds Jumping Time.

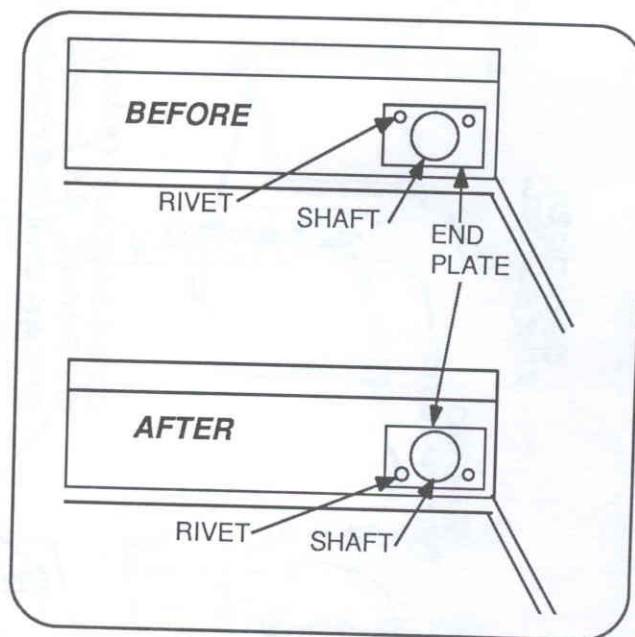
Figure 16. Rotating End Plate.

a. Drill out the two pop rivets securing the corner plate.

b. Remove plate and turn it upside down so that the rivet holes are now at the bottom.

c. Insert crank into the actuator shaft, lift it up and out toward the end of the trailer. While held in this position, drill two new holes using the holes in the plate as a guide. Install rivets to secure plate.

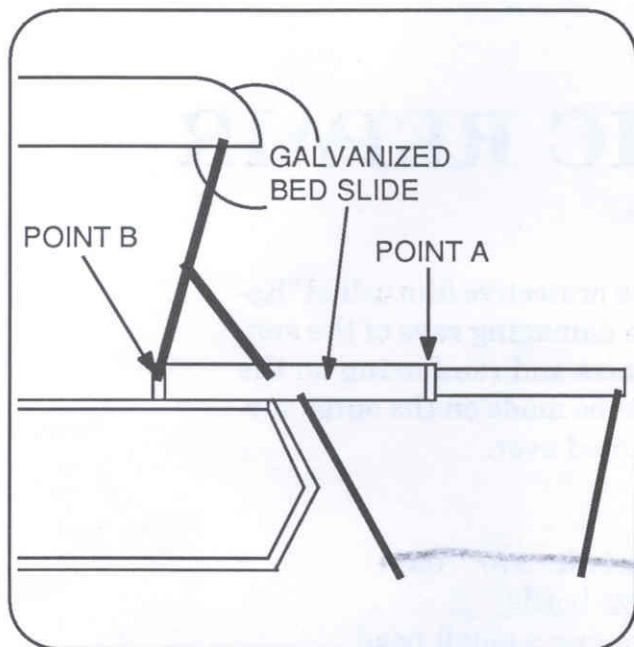
Figure 17. Replacing Bed Slides (1 of 2)

5. Replace slide or slides and slide galvanized slide back over the new nylon slides. Replace the bed stop with two #64 pop rivets.

6. Replace 1/4" rivet to secure road cover support bow to bed slide (point B).

1. Get the roof raised and install a "c" clamp on each bed track to keep the roof up (point B, figure 17).
2. Drill out the two rivets holding the bed stop. Remove the stop on both sides of bed (point A, figure 17).
3. Remove rivets securing bed vinyl seal, remove seal. Remove the bed or slide it out enough to work between the bed and trailer body.
